COMPUTED TOMOGRAPHY OF IMPACT DAMAGE IN HIGH-PRESSURE VESSELS: HYFACTOR PROJECT

HYFACTOR

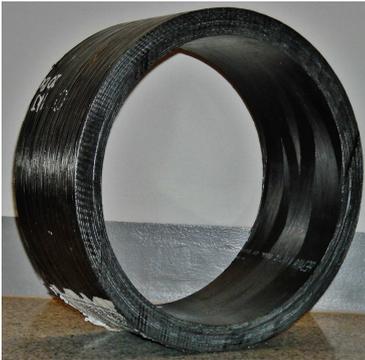
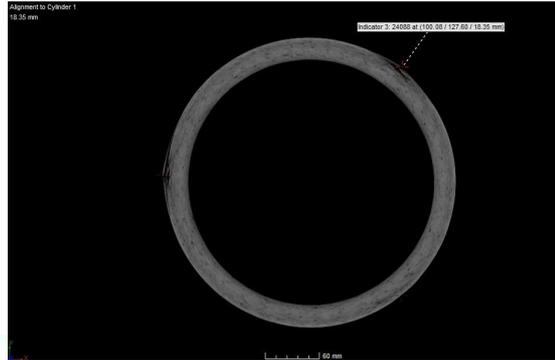
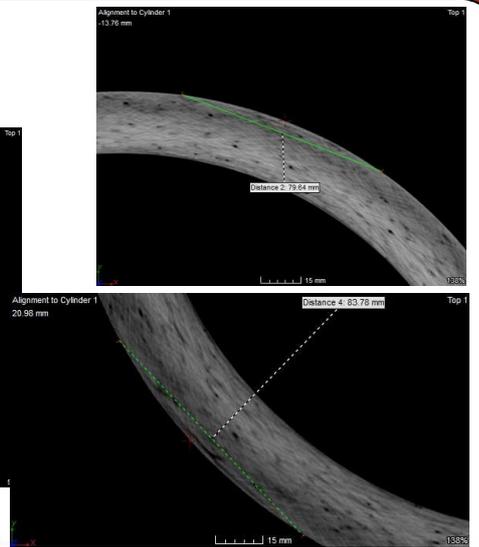
Figure 2 : above: 1kJ impact. Sectional view image X-Y. Hoop layer delamination probably due to the local fibre bundle failure. Delamination dimension is highlighted. below: 3 kJ impact. Sectional view image X-Y. Local fibre failure and macro scale oblique crack. Measurements of macro scale oblique crack are highlighted.

The higher the impact energy, the more severe damage may be seen. 1 kJ impact on COPV constitutes barely-visible damage on the surface and equally unobtrusive damage in CT section, though resulting delaminations are quite extensive.

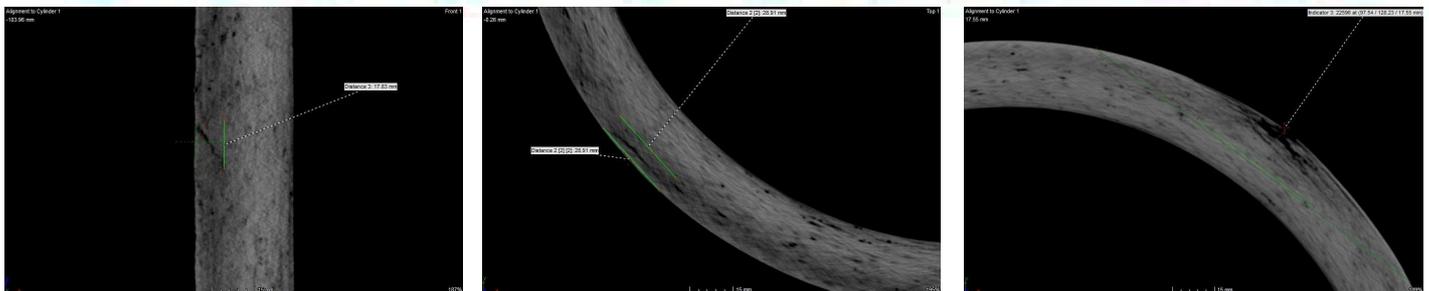
Figure 5 : left: 3 kJ impact. Sectional view image X-Z. Local fibre failure, crack goes deep into the structure of the composite. Measurements of the crack are highlighted. right: Centre of 5kJ impact sectional view images X-Y, fibre failures and delaminations are highlighted.

At higher impact energies, macro-scale cracks and fibre failure start to occur, and delaminations get more visible. The effect of the induced damage on residual performance of COPV will be investigated in following studies in the HyFactor project.
