Project Title: **Pre-normative research on resistance to mechanical impact of composite overwrapped pressure vessels**

Project acronym: **HyPactor**

DELIVERABLE ID	D4.10
Deliverable name	Public summary report on the results of WP4 activities
Lead beneficiary	Institut de Soudure
Contributors

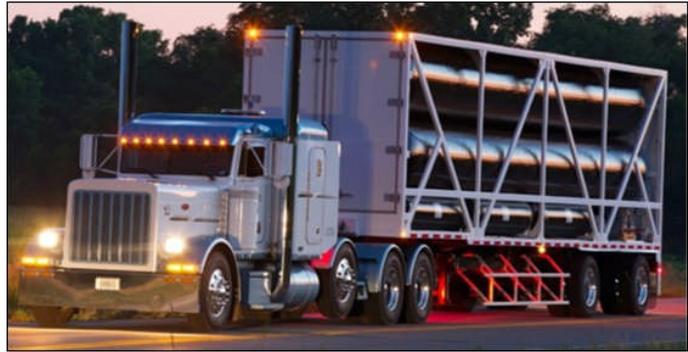
Figure 2: Hexagon Lincoln TITAN™ Trailer on the road.

The goal of this task is to give the operating conditions for the implementation of Non Destructive Testing (NDT) methods on type IV COPV. The main application of such vessel is on gas transportation by trailer (figure 2) and on refuelling stations. Two NDT methods are studied as they are the most mature already supported in standards and potentially used for periodic inspection of COPV: visual inspection of accessible areas and Acoustic Emission Testing during pressurization.
